ExtremeWare Release Notes

Rev 1

Software Version 6.1.9b11

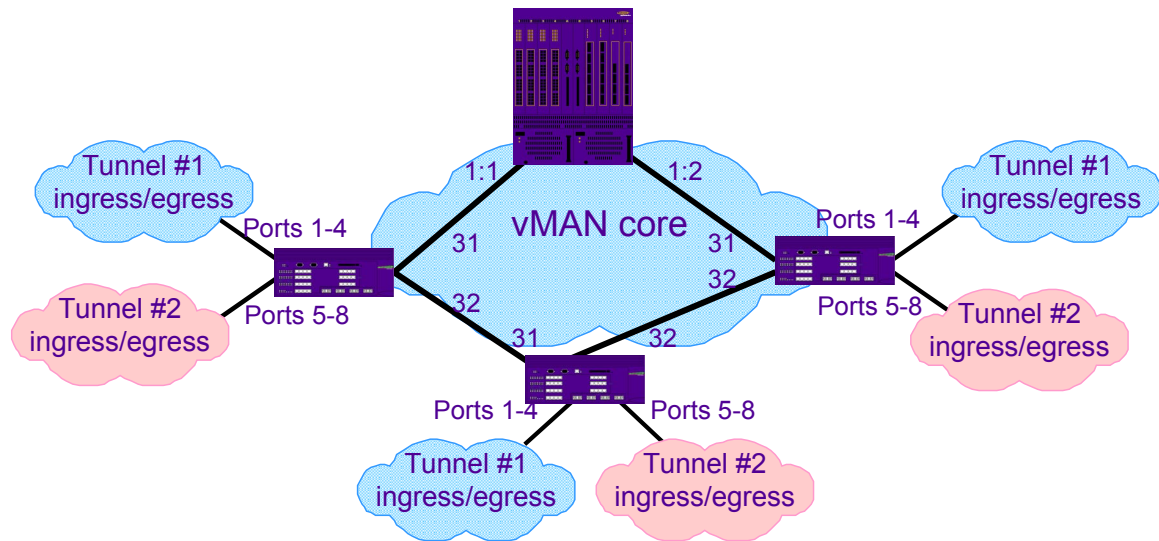
Depicted below is an example configuration with vMANs. Two tunnels are depicted that have ingress/egress ports on each Summit7i.

For all the Summit7i's that are shown, the configuration is:

- 3) create tunnels by creating VLANs and configuring member ports as tagged on switch-to-switch ports and untagged on the tunnel's ingress/egress ports.

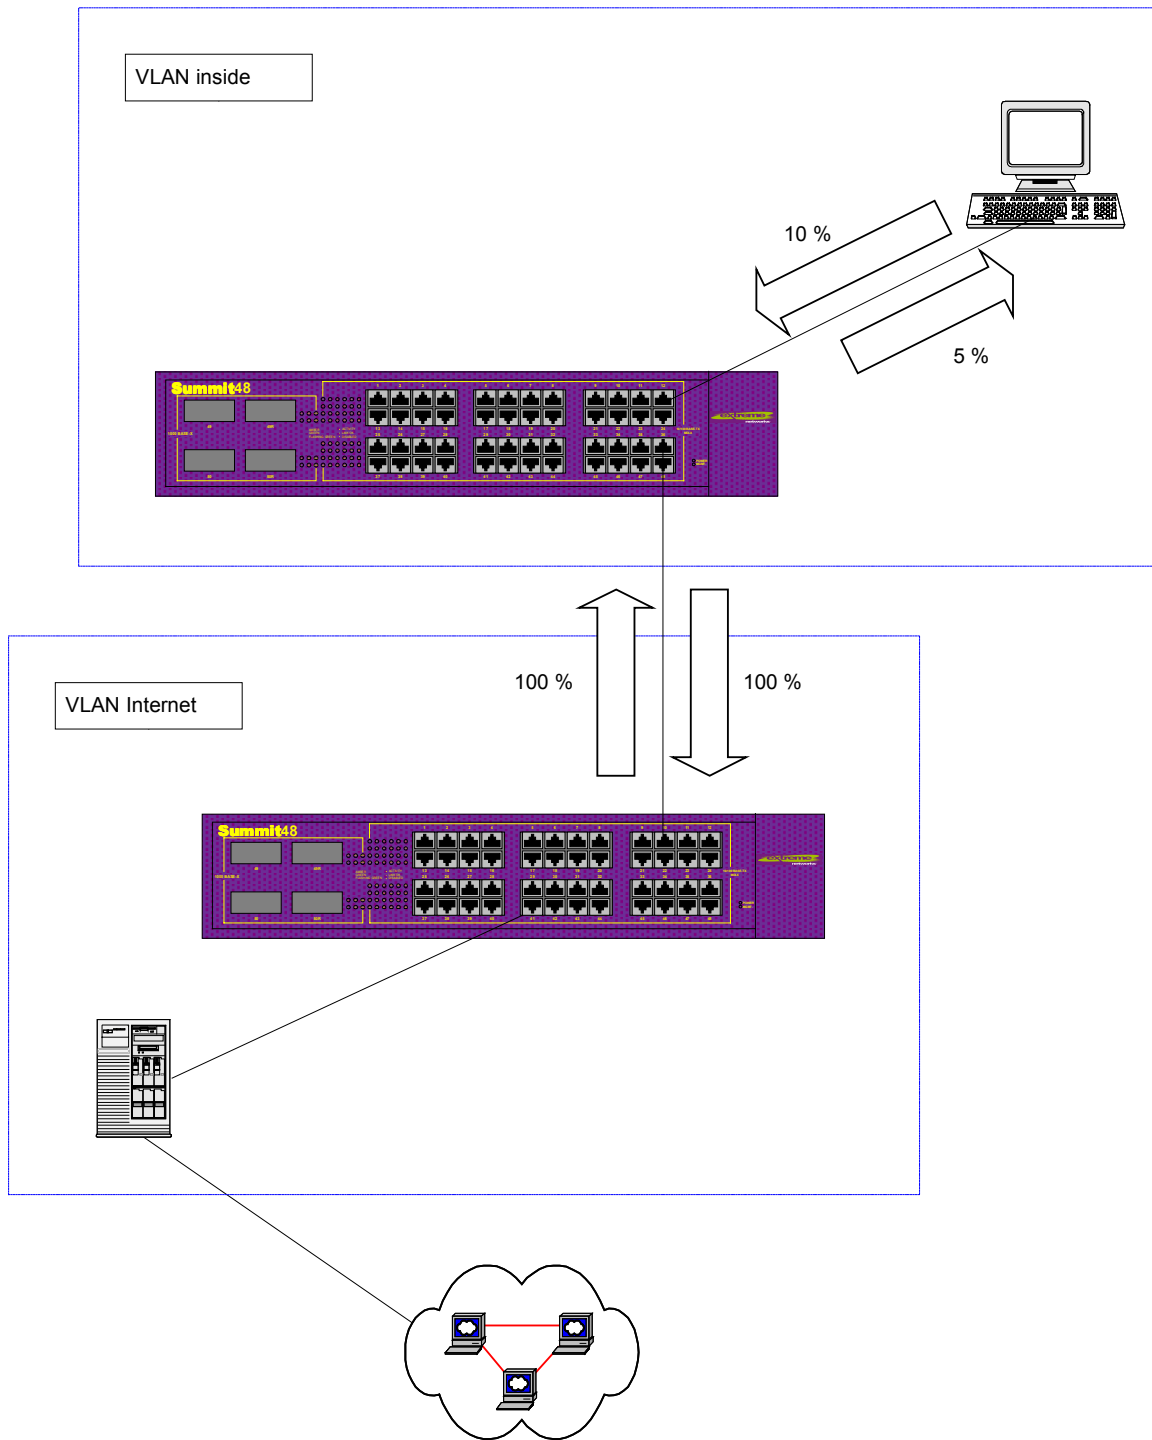
Routing bi-directional rate shaped ports

If traffic between rate-shaped ports is routed, as in the following example, you must assign the same QoS profile to both ports (or both VLANs).

If you assign the rate-shaped ports to different QoS profiles, the switch will only rate-shape traffic through the loopback port.
